11 November 2018 - Maintenance Bulletin - PCBA 5010-4 Battery Analyzer

Applies to units purchased prior to September 2018 - Hardware Versions 1, 2, 3

Part 1 - The Repair - Charge Pump Voltage Spike:

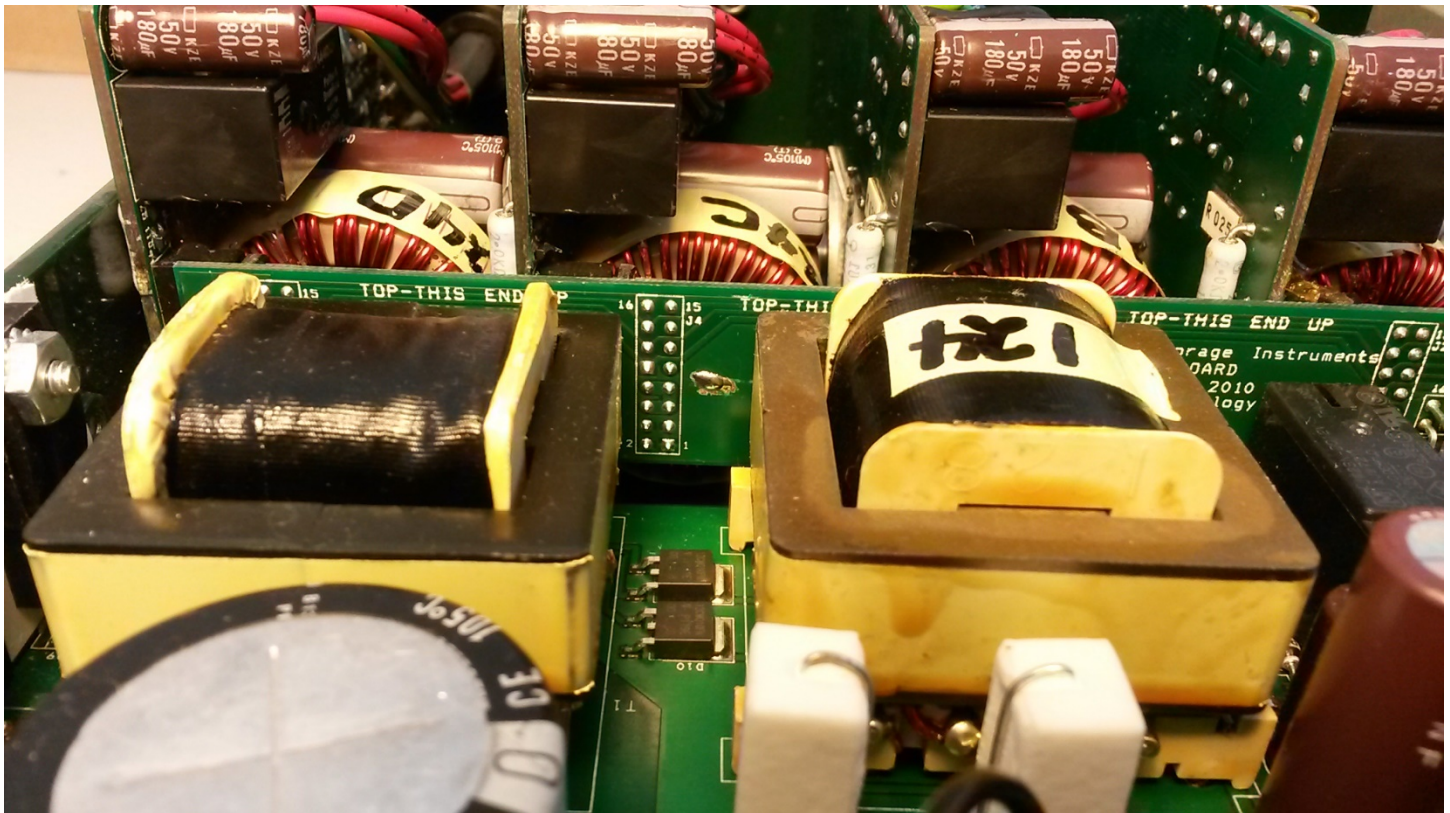
A small capacitor needs to be added between the +38V auxiliary and the +50V supply to suppress a voltage spike that occurs upon initiation of service due to an unforeseen problem since 2008. Luckily both contact points are easy to access from the back side of the bus PCB as shown in figure 1.

Step 2 – Using a small knife, scrape the green solder mask off a small spot on the bus PCB and tin with a spot of solder as shown in Figure 1. Use a rosin type solder flux or similar to ensure a clean contact and wetting.

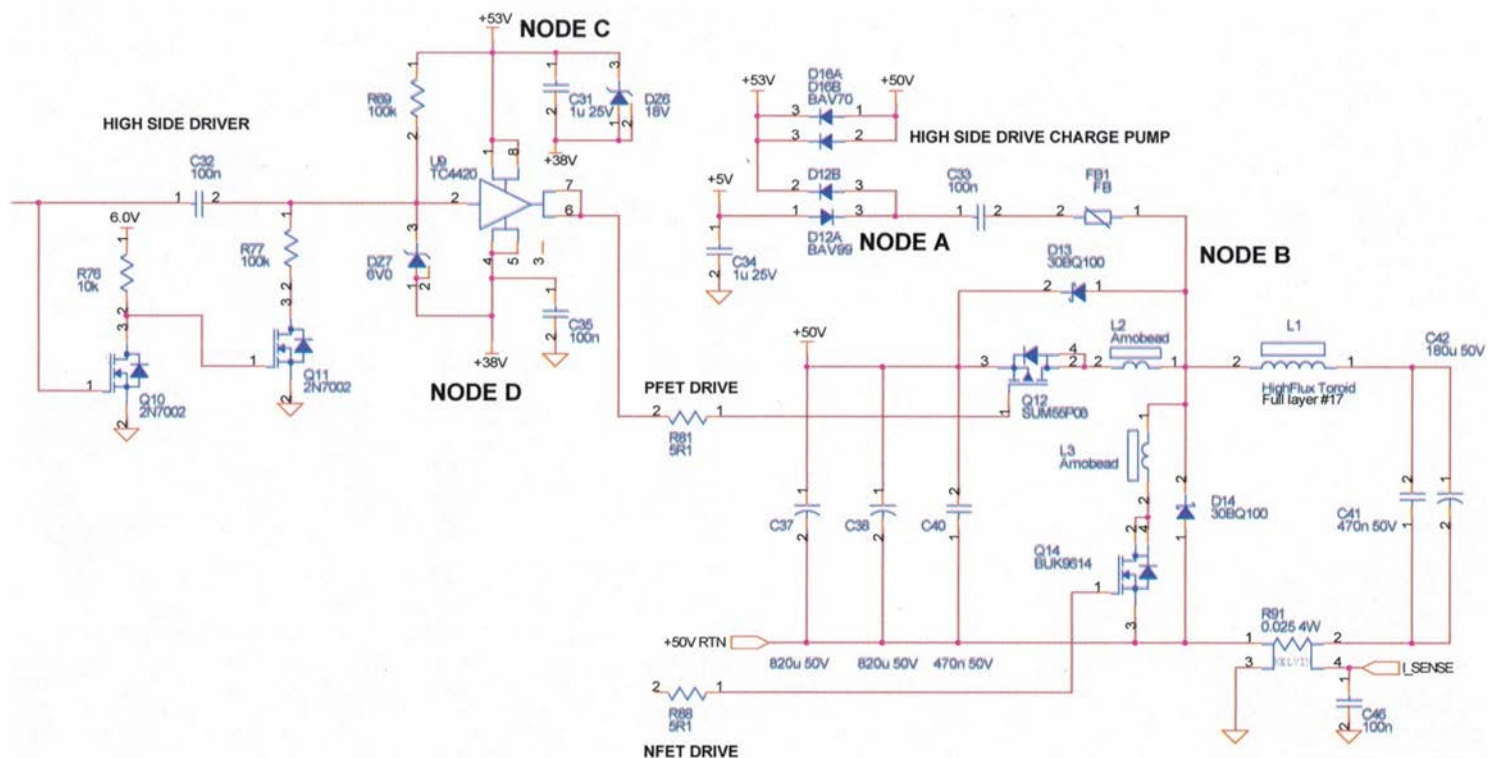
On any given channel, the reverse bias leakage current of D12A and D12B (25-75nA) creates a voltage divider at NODE A causing C33 to charge up to approximately 25 Volts over a 5-15 minute period such that sometime later, upon pressing of the START button to initiate service, PFET Q12 SUM55P06 turns on driving NODE B to rise from zero to 50V in-turn generating a 75V spike into NODE C of the +53V auxiliary which then divides by the capacitance ratio of C31 and C35 resulting in a 4-5V spike at NODE D on the +38V auxiliary at C35. With C35 being only $0.1\mu\text{F} \times 4 \text{ channels} = 0.4\mu\text{F}$ total, it is too small to absorb the current spike without a spike in voltage on the +38V bus which in turn acts like a false ON signal to all the other PFETS of the other channels as the +38V auxiliary is a common connection in the system bus. So the initial spike of one channel can then trigger the other channels to also turn on which creates a cascading effect of voltage spikes at the same time all adding together causing the total spike voltage to reach as high as 10V as seen on the scope captures included on next page.

The problem arises if by chance another channel is already in service and running with its lower NFET ON at the time of the voltage spike into the +38V auxiliary that causes the PFET to also turn ON at the same time. This is when the channel can blow when both the NFET and PFET are ON at the same time as it creates a short circuit across the +50V main supply. A deadly situation that need only happen once and the channel will blow, short circuit, making the whole analyzer thereafter inoperable.

Figure 5. – Channel schematic of high side driver, charge pump and power section.

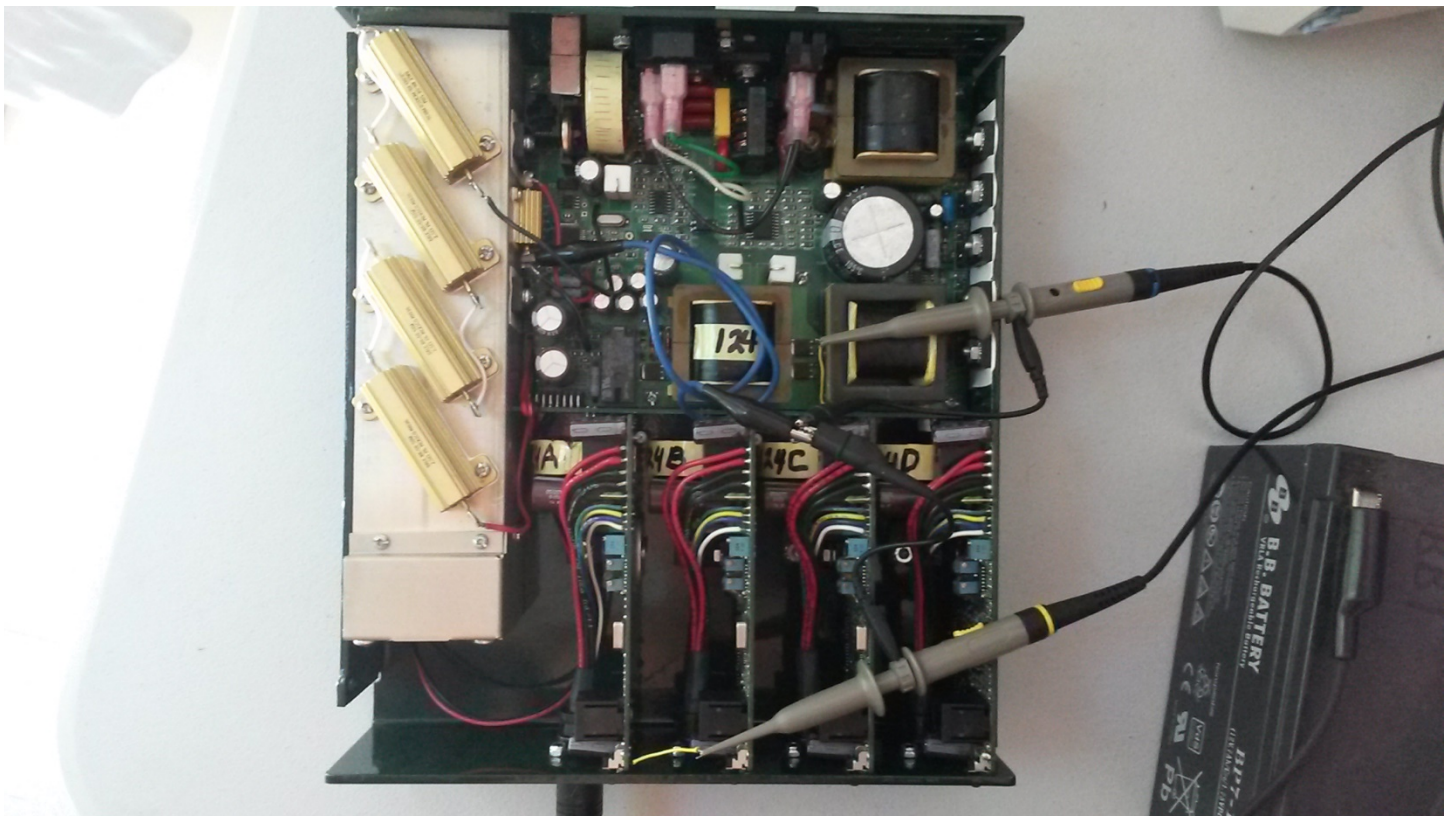
Figure 6 shows the scope connections, Figure 7 shows the voltage spike on the +38V auxiliary **prior to repair**.

Figure 6. – Scope triggered off channel 1 rising edge, large 10V spike occurs approximately 12ms later.

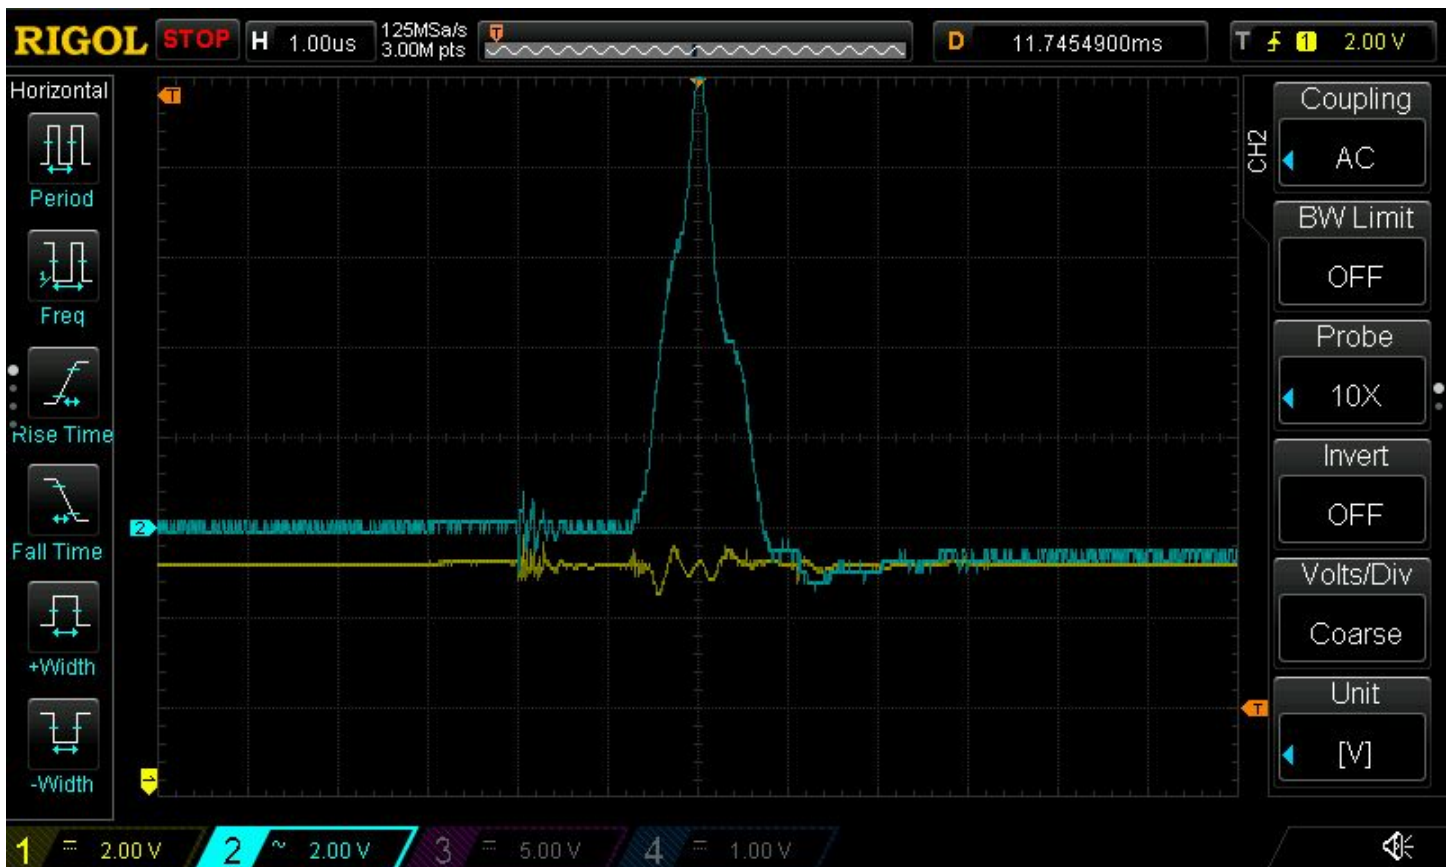
Figure 7. - Voltage spike on +38V auxiliary before repair, 10V peak.

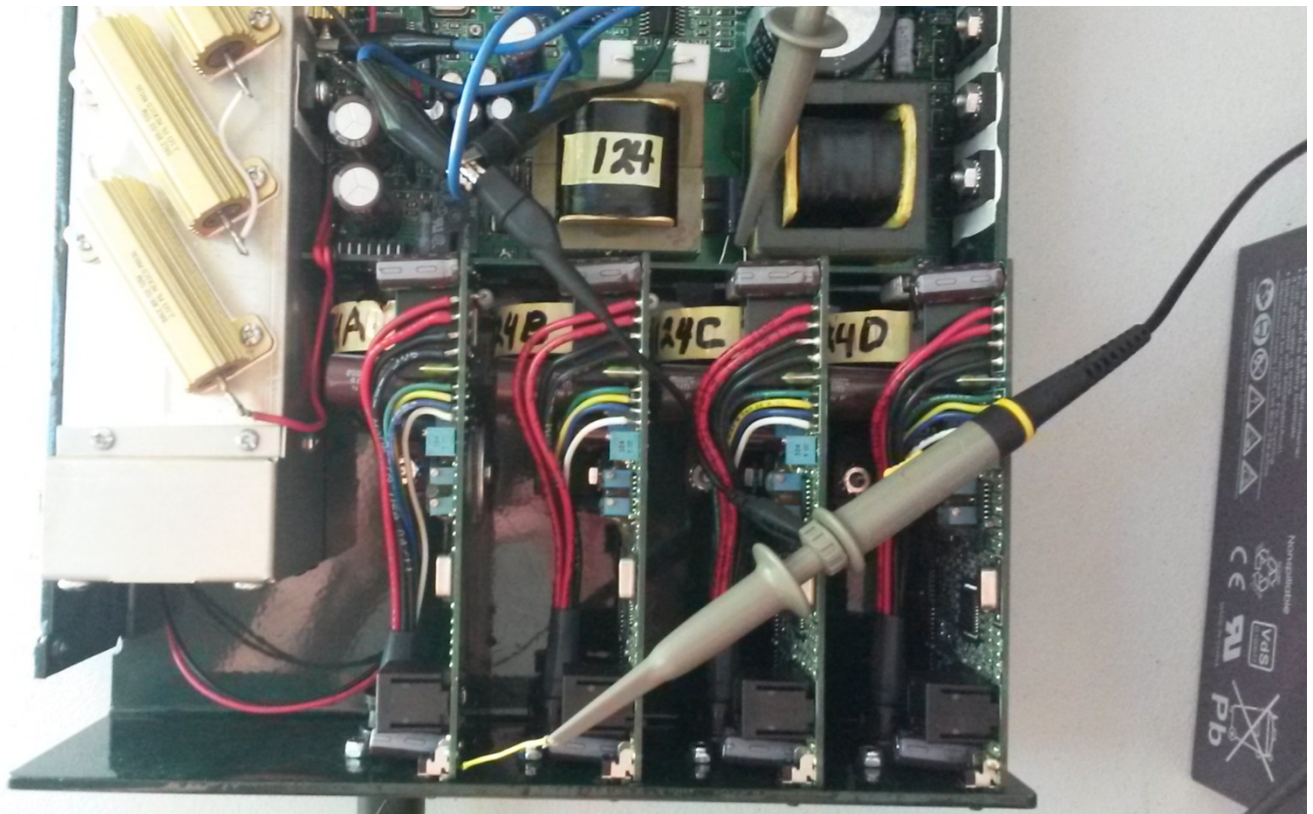
Figure 8 shows the scope connections, Figure 9 shows the voltage spike on the +38V auxiliary **after the repair**.

Figure 8. – Scope triggered off channel 1 rising edge, much smaller 2V spike occurs approximately 12ms later.

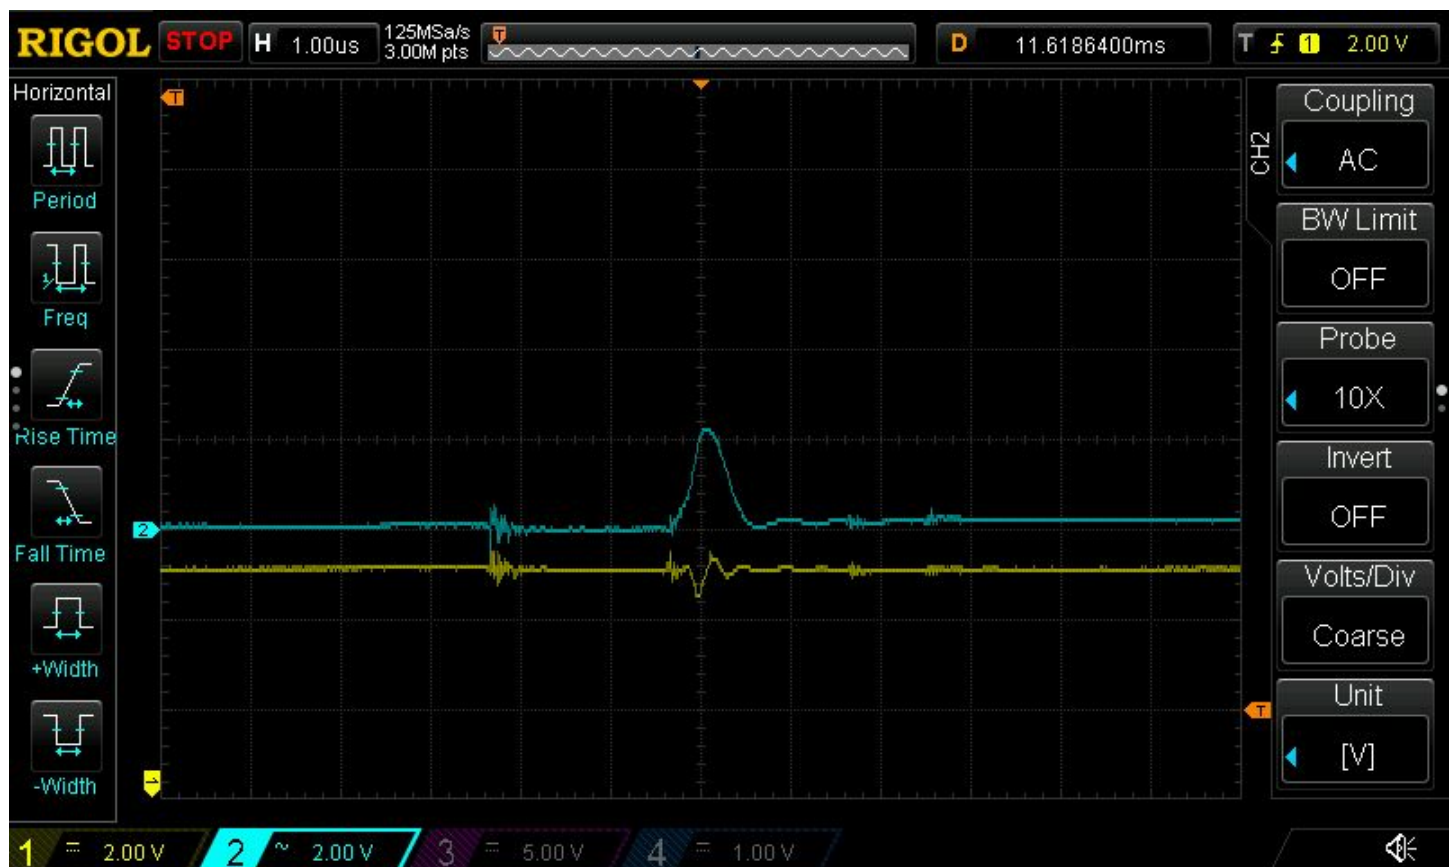
Figure 9. – Voltage spike on +38V auxiliary after repair, 2Vpeak.
